# Meyer Puts The Brakes On Leaky Airlocks

In 1998 American Vacuum, a Skokie, IL based system manufacturer contacted, Wm.W. Meyer & Sons looking for the solution to a problematic application.

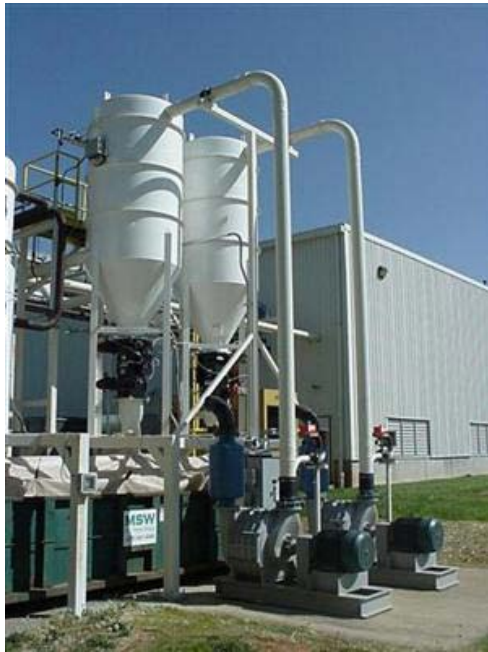
Due to the high vacuum & abrasive material, Meyer engineers determined that a "Double Flapgate Valve" would provide the most effective solution to the end-users issues. The unique design combined reliable, long term performance value with low maintenance cost.

**Non-jamming Design:** can handle a wide range of particle sizes, up to 6"

**Seat and Gate:** supplied in High Chrome White Iron with outstanding abrasion resistant characteristics.

**Stainless Steel Shafts:** 25 to 60% larger than most competitors. No downtime due to shaft fatigue or failure.

**Rotary Actuators:** Totally enclosed – no need for OSHA guards.

**Ease of Maintenance:** Front and Rear access covers for inspection or change of parts eliminating the need to remove valve for servicing.

After twelve years of service the Double Flapgate Valve has been trouble free and is functioning with the original parts. In addition the customer has reported energy savings and down-time was virtually eliminated.
